## Boardings at Sea: Why Fishery Missions Matter

Story and photos by PA3 Rob Simpson, PADET St. Petersburg, Fla.

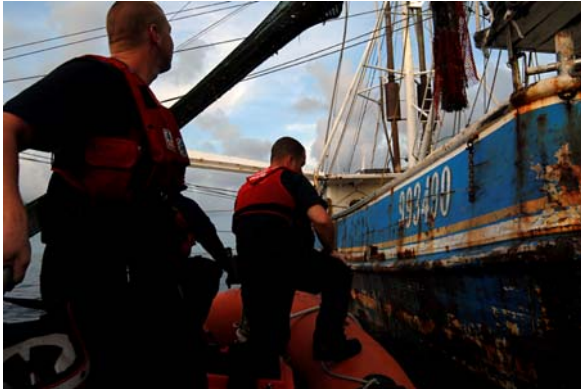
GULF OF MEXICO – Chief Petty Officer Devin R. Spencer, a *Resolute* boarding officer, prepares to board the fishing vessel *Tran's Express*. The voyage of the *Tran's Express* was terminated due to flooding in the engine compartment and having empty, un-inspected fire extinguishers. The vessel was escorted back to their homeport where they were able to fix the problems and be inspected again by a Coast Guard marine inspector before the vessel was allowed to leave port. Coast Guard photograph by PA3 Rob Simpson.

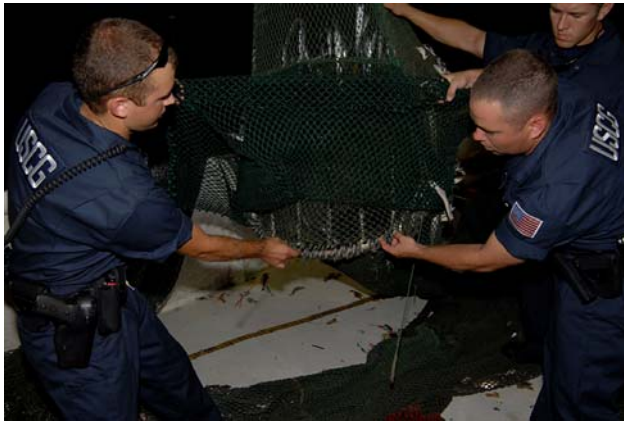
GULF OF MEXICO - *Resolute* boarding officers inspect the skirt on a shrimp net placed above the TED. The net's escape chute was sewn shut, shown here as the lighter green net, and a darker green false skirt was sewn over it to make the TED appear functional. The chutes above the TEDs must remain open to allow sea turtles to be ejected from the net. Coast Guard photograph by PA3 Rob Simpson.
